BELZONA ENHANCES EFFICIENCY OF NEW PUMPS

Industry: Water / Wastewater
Application: CEP-Centrifugal Pumps
Substrate: Cast iron case and bronze impeller
Products: * Belzona® 1111 (Super Metal) ,
* Belzona® 1341 (Supermetalglide) ,

Customer Location: Water supply company, Bulgaria
Application Date: February - April, 2010

New double end suction centrifugal Worthington pump

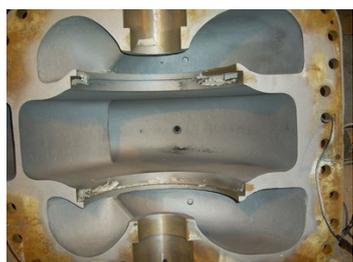
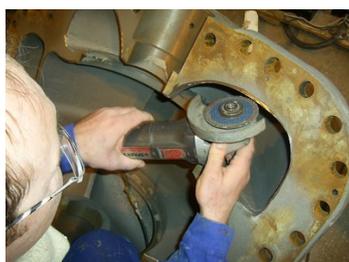
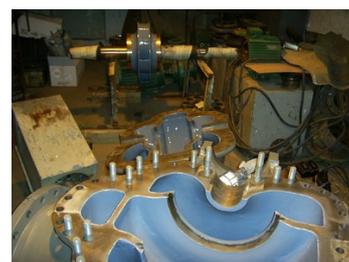
- * Grit blasted casing ,
- * Preparation of rebate grooves ,
- * First coat of Belzona® 1341 applied ,
- * Finished application with second coat of Belzona® 1341 ,

Application procedures were carried out in accordance with Belzona Know-How System Leaflets CEP-3 and CEP-10.

As a result of applied Belzona efficiency enhancement coating a reduced power consumption of 35 kWh was registered and efficiency was increased to 3.5% at duty point. Two new pumps were coated with Belzona during this application period.
