# BELZONA PROTECTS NEW HEAT EXCHANGER

**Industry:** Heating, Ventilation & Air Conditioning  
**Application:** HEX-Heat Exchangers  
**Substrate:** Cast iron  
**Products:** \* Belzona® 1321 (Ceramic S Metal) ,

**Customer Location:** HVAC company, Colorado  
**Application Date:** June 2010

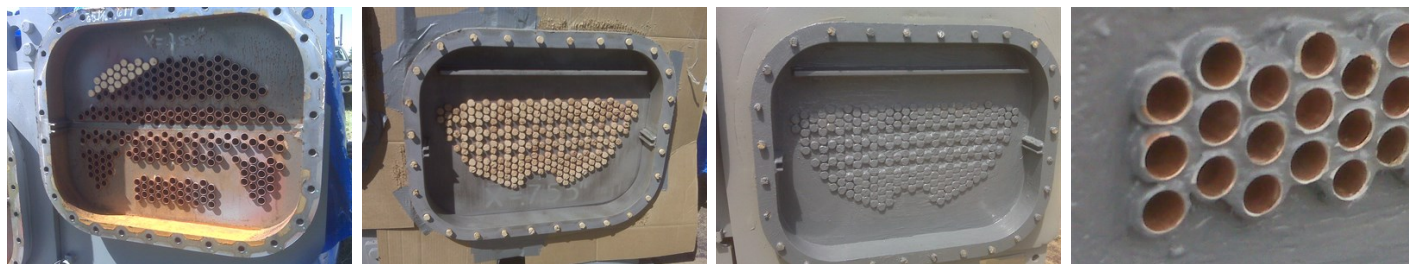
## Photograph Descriptions

Protection against anticipated corrosion on new heat exchanger.

- \* New chiller from factory ,
- \* Blasted and corked tube-sheet ,
- \* Belzona barrier system applied ,
- \* Honed and cleaned tubes ,

New chiller tube-sheet and end covers

Application was carried out in accordance with Belzona Know-How System Leaflet HEX-2. After blasting tube-sheet and end covers components were coated with Belzona® 1321.
