BELZONA PROTECTS NEW HEAT EXCHANGERS

ID: 1516

Application: *HEX-Heat Exchangers*

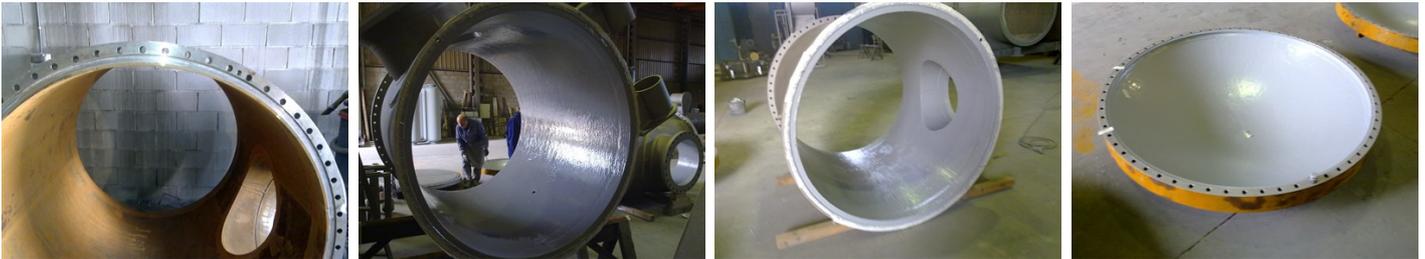
Photograph Descriptions

These units required corrosion protection. They were designed to operate with sea water at 70°C.

- * Part to be coated, before blasting ,
- * Coating with Belzona® 5891 ,
- * End heads coated with Belzona® 5891 ,
- * Cover coated with Belzona® 5891 ,

The application was carried out in accordance with Belzona Know-How System Leaflet HEX-3.

Belzona coated the equipment rapidly and economically, without a need for more expensive and complicated systems such as ebonite, making it possible to coat the equipment onsite.
