DUCT SEALING WITH BELZONA® 4211

ID: 153

Customer Location: Telecommunications in India
Application Date: August 1999

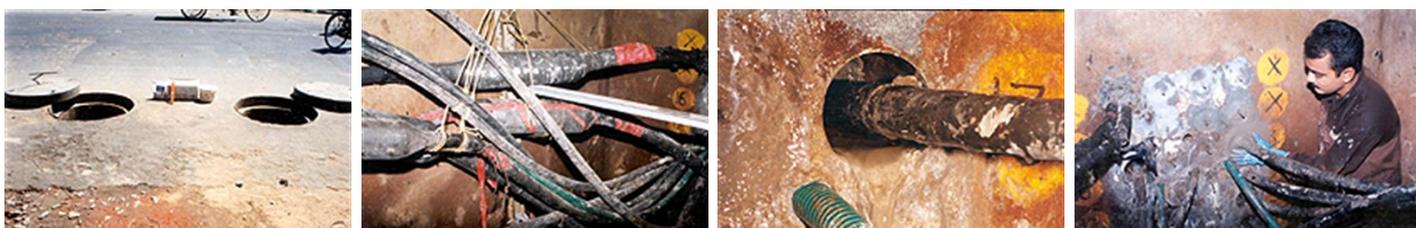
Photograph Descriptions

Water leakage into the chambers causing cable joints to be submerged and extensive disruptions to telephone lines. Problem is particularly great during the monsoon.

- * Access to the chambers ,
- * The cable connections ,
- * & 4. Application of Belzona® 4211 underway ,

Application was carried out in accordance with Belzona System Leaflet VPF-11b suitably modified.

"Live" leaks were effectively sealed eliminating major disruption to the local and national communication systems.
