BELZONA FOOD PROCESSING FLOOR

ID: 157

Customer Location: Food Processing Plant in Minnesota
Application Date: August 1995

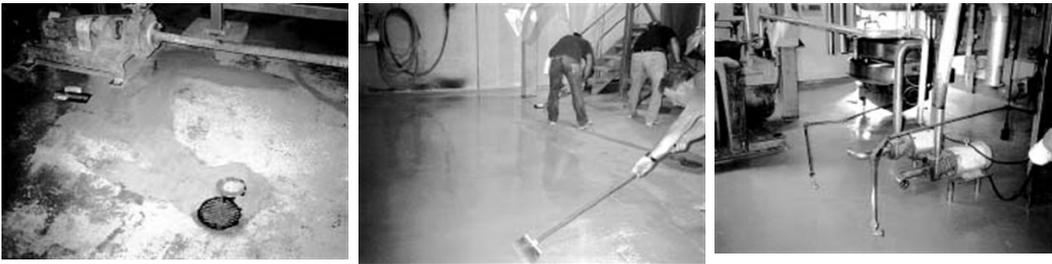
Photograph Descriptions

The floor was badly deteriorated from constant wear and washings.

- * Severely damaged areas patched with Belzona® 4131 ,
- * Application of slurry Belzona® 4111/4151 system in progress ,
- * The completed application ,

The application was carried out in accordance with a modified version of Belzona Know-How Leaflet FPA-1.
