BELZONA BRIDGES A SLIPPERY PROBLEM

ID: 1570

Industry: *Buildings & Structures*
 Application: *FPA-Floor Problem Areas*
 Substrate: *Other*
 Products: *Belzona 4411 (Granogrip)*

Customer Location: *City of Paris, France*
 Application Date: *2000 & 2003*

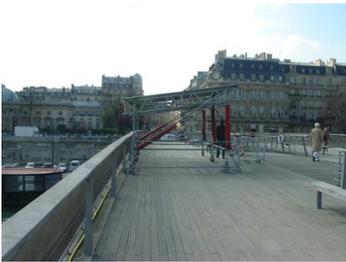
Non-disruptive application in 2000

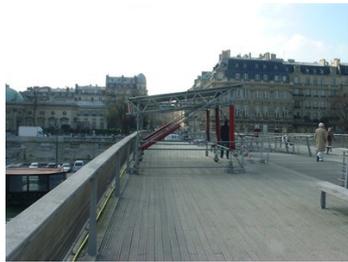
Non-disruptive application in 2000

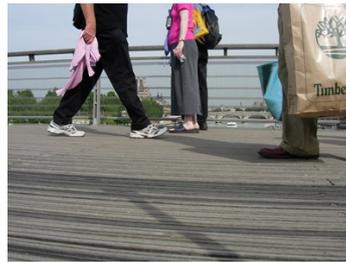
Users in 2005

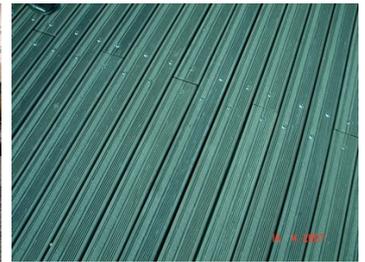
Close up in 2007
