# BELZONA REPAIRS UNDERWATER PIPE ON OFFSHORE PLATFORM

ID: 1582

Sump pipe on oil and gas platform

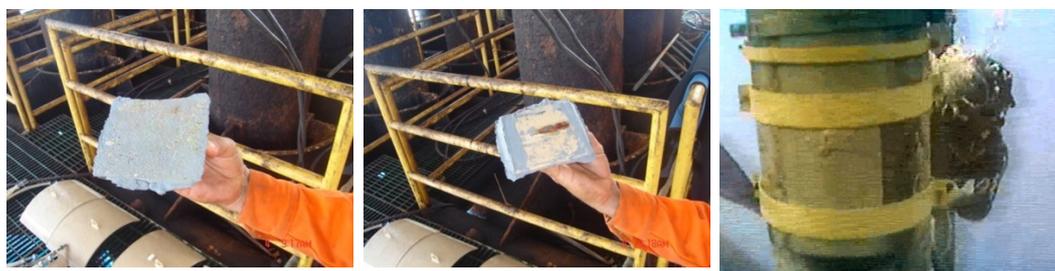
Sump pipe was cracked due to impact. It was required to seal the affected area under water.

- \* Adhesion test being carried out with plates coated with Belzona® 5831 prior to application ,
- \* Testing Belzona® 1161 on edges of plate under immersed conditions ,
- \* Application being carried out by divers under water ,

Application was carried out using a modified version of Belzona Know-How System Leaflet VPF-11a. Surface was cleaned in accordance with ISO 8501-1 St2/3 using pneumatic sander. Prior to commencement of the application several plates were coated with Belzona® 5831 for future corrosion protection. Plates bonded in place by diver using Belzona® 1161. Clamps were used to hold plates in place during curing process.

Practical training was carried out with the divers prior to carrying out the actual application. Upon completion, inspection was carried out and a small leak was detected. The leak was repaired with the Belzona® 1161/5831 system. This repair is in perfect condition when last inspected in 2010.
