BELZONA PROVIDES LONG TERM SOLUTION FOR FGD REACTORS

Customer Location: Power Plant, North Dakota

Reactor contains corrosive alkaline slurry of gypsum and lime. Coating required for corrosion protection.

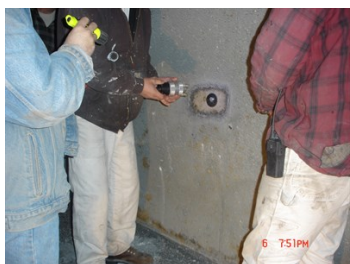
- * Coating behind crust of slurry ,
- * Coating from 2000 application ,
- * Adhesion testing ,
- * Adhesion testing ,

The walls and floor were coated with Belzona® 5811. Due to higher temperatures ceiling and roof coated with Belzona® 5891. The applications have been carried out in stages over a 7 year period starting in 2000. Unit one was inspected in 2007 and found to be in excellent condition. Adhesion tests were performed on the walls of the reactor (oldest part of the coating) and found to exceed 1600 psi direct tension as per ASTM D4541.
