# Belzona PROTECTS POTABLE WATER TANKS

ID: 1612

Customer Location: *Shipyards, Mallorca, Spain*  
Application Date: *December 2010*

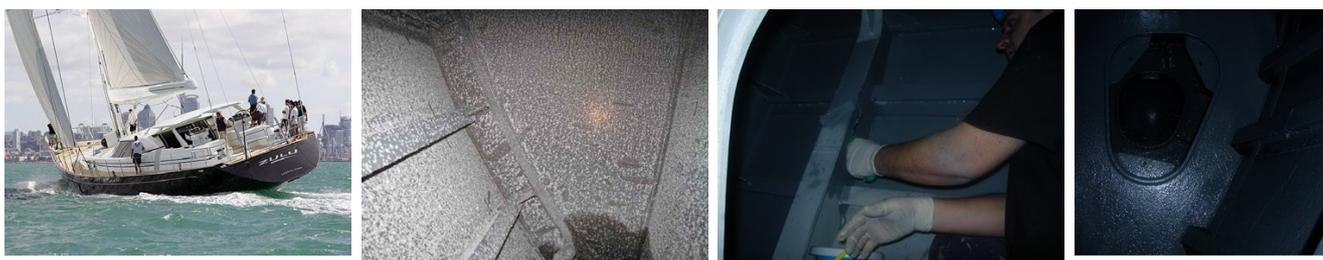
## Photograph Descriptions

*Two aluminium potable water tanks were suffering pitting corrosion that was decreasing the wall thickness. The substrate had to be protected with a potable water approved coating.*

- \* General view of the boat ,
- \* Corrosion in the tank ,
- \* Coating with Belzona<sup>®</sup> 5811DW ,
- \* Final aspect after application ,

The application was carried out in accordance with Belzona Know-How System Leaflet TCC-5.

Belzona products safely protected the tanks from corrosion and allowed a fast and easy back to service with an in-situ application. This avoided replacement of the equipment, making significant cost savings.
