BELZONA PROTECTS LARGE COLLECTION TANK

ID: 1614

Customer Location: Chemical park, Germany
Application Date: December 2010

Underground collection tank for waste surface water

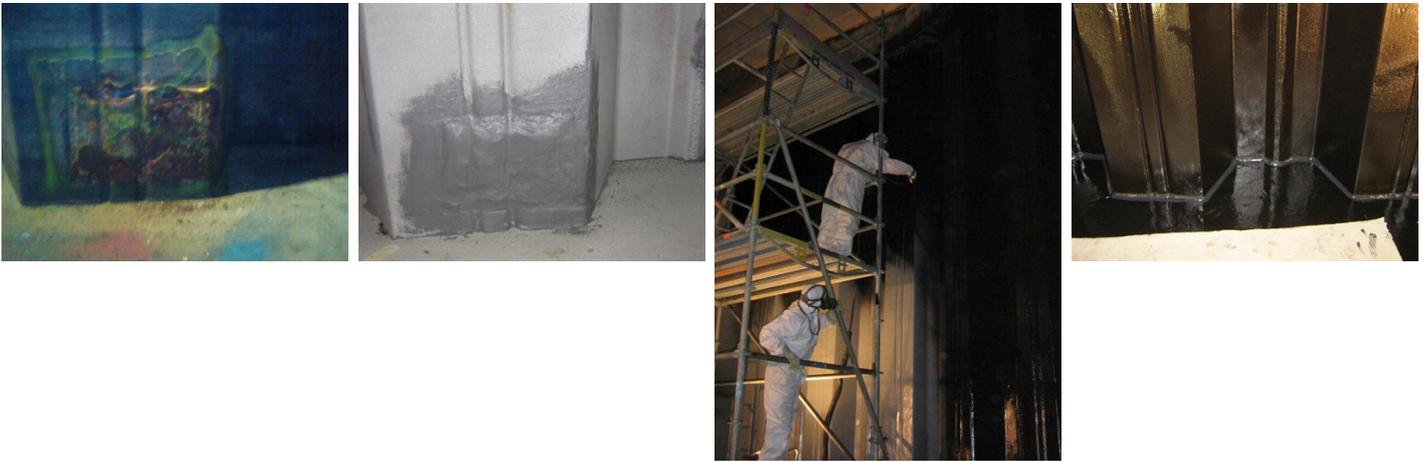
Photograph Descriptions

Breakdown of the original coating had allowed corrosion pitting to occur. some leaks were occurring on the walls, particularly where wall meets the concrete tank floor.

- * Pitting corrosion on tank walls ,
- * Rebuild and reinforced area with Belzona® 1111 ,
- * Spray-applied second layer of Belzona® 5811 ,
- * Completed application ,

Application was carried out in accordance with Belzona Know-How System Leaflets TCC-1, TCC-5 & TCC-9. After surface preparation, Belzona® 1111 was used to bond reinforcement steel sheets to areas affected by pitting corrosion. Belzona® 4111 was used to

repair damaged areas on the concrete tank base. The entire collection tank was coated with Belzona® 5811 applying two coats by airless spray. Lastly, an elastomeric fillet was created by applying Belzona® 2211 where steel walls joined onto the concrete base.
