# BELZONA OVERCOMES PROBLEM OF LEAD THEFT

ID: 1643

Application: RPA-Roof Problem Areas

Customer Location: Local School, UK

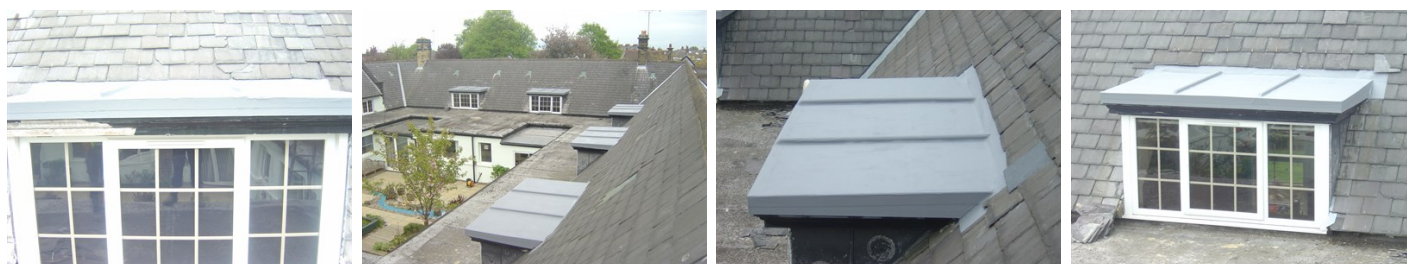
## Photograph Descriptions

*This school had recently suffered from theft of the lead from their roof. The damage was so extensive that if not addressed, it would lead to structural defects resulting in a potentially disruptive high cost maintenance repair.*

- \* Window before application ,
- \* General view of the roof ,
- \* Application completed ,
- \* Application completed ,

Application was carried out in accordance with Belzona Know-How System Leaflet RPA-2. Roof was felted prior to sealing with fully reinforced Belzona® 3111 system.

The repairs were completed in less than one week. Revisiting the application in 2010, the school has not experienced any further problems, and the repair is still in excellent condition.
