BELZONA CHILLS OUT BREWERY

Industry: Heating, Ventilation & Air Conditioning
Application: HEX-Heat Exchangers
Substrate: Copper tubes, steel tube sheet
Products: * Belzona® 1311 (Ceramic R-Metal) ,
* Belzona® 1321 (Ceramic S-Metal) ,

Customer Location: A Mid-Western Brewery in Missouri
Application Date: December 1995

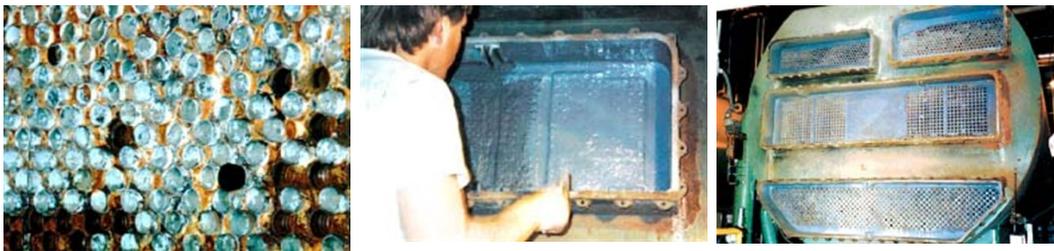
Photograph Descriptions

The tube sheet was badly eroded/corroded. There were numerous leaks between the tubes and the tube sheet.

- * Close up view of one of the eroded/corroded areas ,
- * Application of Belzona® 1321 over Belzona® 1311 ,
- * Completed job, tube sheet rebuilt ,

The application was carried out in accordance with Belzona Know-How Leaflet HEX-1.

The area coated was 60 sq. ft. on each end. Two more units are scheduled this year. The customer benefited by saving replacement costs, reduced down time and continuation of the manufacturing process.
