Belzona refurbishes schools floor

ID: 1696

Industry: Buildings & Structures
Application: FPA-Floor Problem Areas
Substrate: Concrete with an existing coating unknown
Products: * Belzona® 5231 SG Laminate ,

Customer Location: Cheltenham, UK
Application Date: October 2010

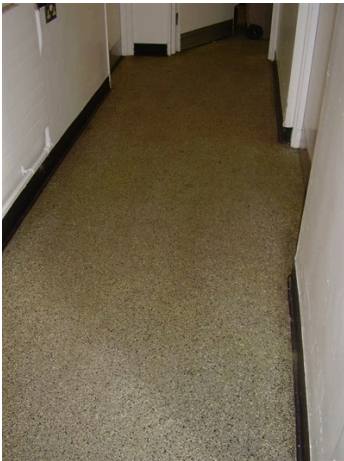
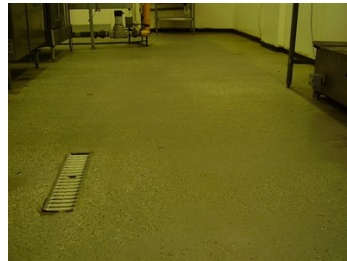
They had a few slips on the existing floor and requires a quick curing application which could be carried out within four days start to finish with no solvent smells.

* Corridor prior to the application Kitchen prior to the application Corridor after application Kitchen after application ,

Application was carried out in accordance with Belzona Know-How System Leaflet FPA-1. The application was carried out in three steps, mechanical abrasion, clean/degrease and then, two coats of Belzona® 5231.

They required a seamless systems, solvent free with 10% aggregate to provide a positive grip system which is also chemical resistance and quick curing for less down time.
