SKIN COOLERS ON A U.S. NAVY SUB SEALED WITH BELZONA

Customer Location: *US Navy Deep-Diving Research Submarine*

Application: *SOS-Ships and Offshore Structures*

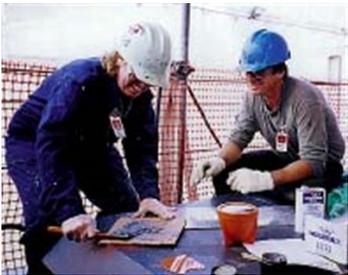
Coolant leaks through inner walls of skin coolers.

- * Shipyard applicators learning how to use the material. ,
- * A sealed section of plate between two of the structural ribs of the submarine. ,
- * The submarine with skin coolers sealed just prior to launch from the drydock. ,

Skin coolers are heat exchangers for component cooling water that operate by passing the coolant fluid against the cold steel of the submarine hull. Coolant fluid is contained in a space between a thin steel plate set just inside the inner surface of the pressure hull, and the hull itself.

Pressure testing was carried out. Each time leaks were sealed, the compressed air test was able to be conducted at higher pressures, enabling smaller holes to be located and sealed.
