# SKIN COOLERS ON A U.S. NAVY SUB SEALED WITH BELZONA

Customer Location: US Navy Deep-Diving Research  
Submarine

Coolant leaks through inner walls of skin coolers.

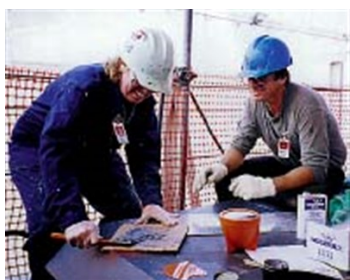
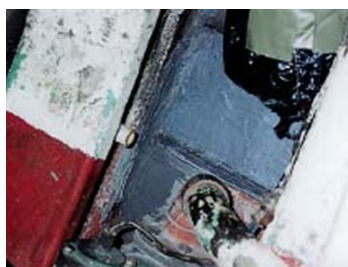
- \* Shipyard applicators learning how to use the material. ,
- \* A sealed section of plate between two of the structural ribs of the submarine. ,
- \* The submarine with skin coolers sealed just prior to launch from the drydock. ,

Skin coolers are heat exchangers for component cooling water that operate by passing the coolant fluid against the cold steel of the submarine hull. Coolant fluid is contained in a space between a thin steel plate set just inside the inner surface of the pressure hull, and the hull itself.

Pressure testing was carried out. Each time leaks were sealed, the compressed air test was able to be conducted at higher pressures, enabling smaller holes to be located and sealed.
