BELZONA PROTECTS POWER STATION CHIMNEY STACK

ID: 1718

Customer Location: Powerstation, Zambrow, Poland
Application Date: 2004

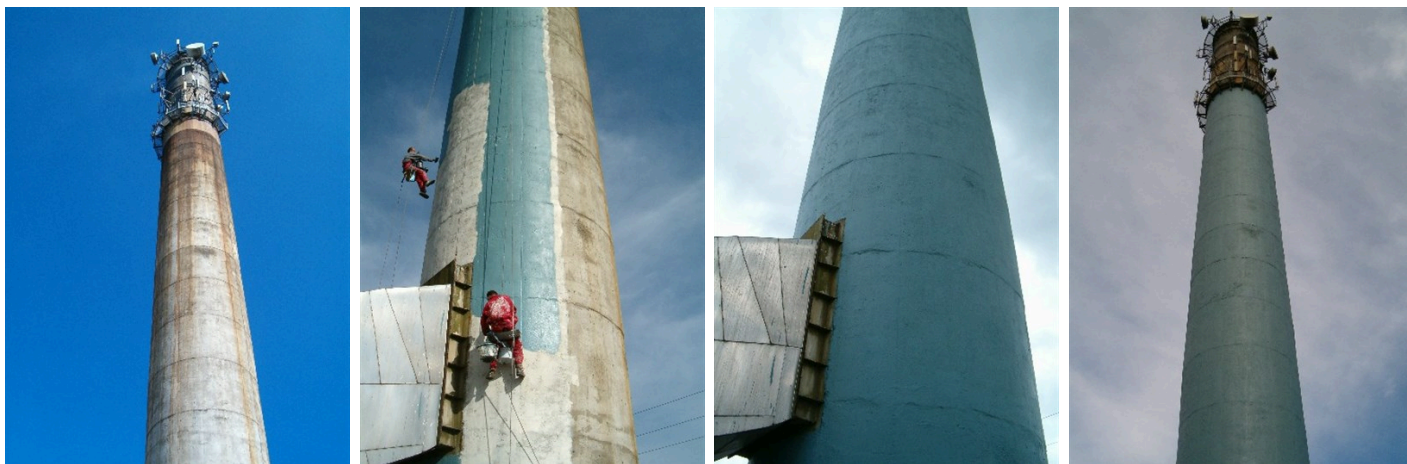
The concrete had become deteriorated from the locally generated fumes and required protection.

- * Before application ,
- * Application via rope access ,
- * Close up of completed application ,
- * General view of the protected stack ,

The application was carried out in accordance with a modified Belzona Know-How System Leaflet WPA-2. To reduce disruption Rope Access technicians were used to complete the application.
