# BELZONA SEALS AT POINT OF NO RETURN

ID: 1721

Non-return flap valves for water pumps.

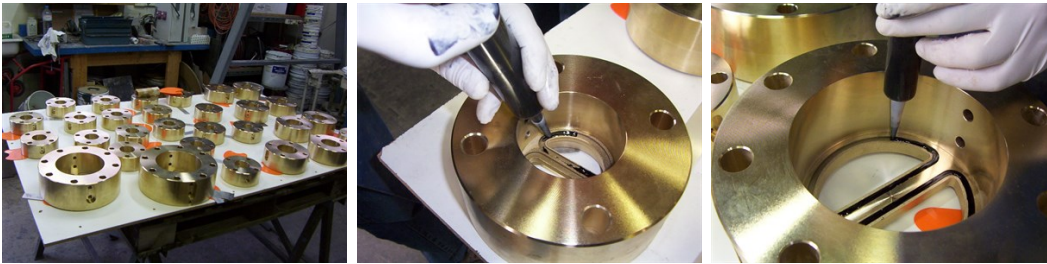
## Photograph Descriptions

- \* Valves awaiting gasket ,
- \* Small Valve having Belzona® 2131 applied ,
- \* Large valve having Belzona® 2131 applied ,

The application was carried out using a modified version of Belzona Know-How System Leaflet GSS-1. Extreme care was taken during this complicated application, as the photos illustrate.
