BELZONA LEAD CHAPEL ROOF

ID: 175

Application: RPA-Roof Problem Areas

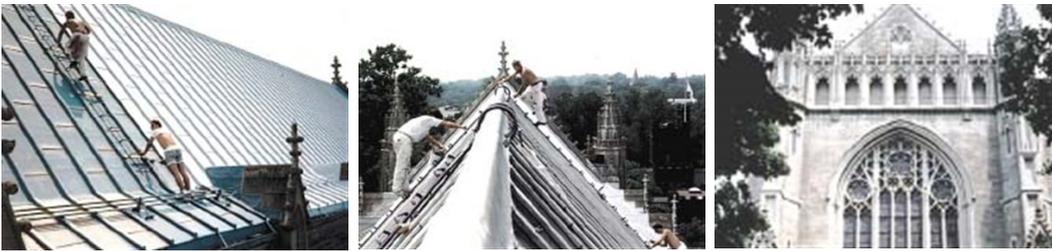
Deteriorating lead roof required long-term protection.

* Belzona® 3111 (Flexible Membrane) applied to the right, Belzona® 3921 (GSC Surface Conditioner) being applied at left, uncoated section lower left. ,

* Work continues at the apex. ,

* Front view of the chapel, lead roof protected. ,

This 70-year-old roof had experienced deterioration over the years due to atmospheric conditions. The university was considering replacement, however, due to the prestigious work that was done on the lead roofs of the House of Lords in the U.K., Belzona was chosen for this project and extended the life of the lead roof.

Application was carried out in accordance with a modified version of Belzona Know-How Leaflet RPA-1.
