# BELZONA STAIRWELL MADE SAFE

ID: 176

| Industry: | General Industry | Customer Location: | U.S. Naval Base in South Mississippi, U.S.A. |
| Application: | FPA-Floor Problem Areas | Application Date: | December 1995 |

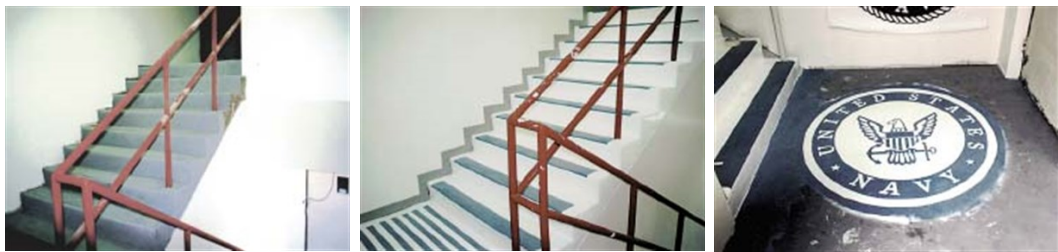
Stairs were spalled and deteriorated and required a non-slip safety surface.

- \* Steps resurfaced with Belzona® 4131 (Magma Screed). ,
- \* Belzona® 5111 (Ceramic Cladding) applied for aesthetic reasons, and Belzona® 1341 (Supermetalglide) grip system applied primarily for safety reasons. ,
- \* At the foot of the stairs, the non-slip Navy logo was created with a stencil. ,

Application was carried out in accordance with Belzona Know-How Leaflets FPA-1 and FPA-8.

The application of several Belzona products provided a safe and aesthetically pleasing stairwell, suitable for Navy V.I.P.'s.
