BELZONA SEALANT FOR METHANE POWERED ENGINE PAD

ID: 178

Customer Location: Wastewater Treatment Plant in Texas,
U.S.A.

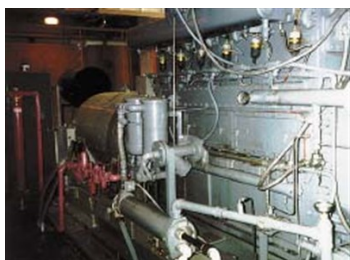
Old cork expansion joint material hardened, allowing vibration to crack the floor outside of the joint area.

- * View of the engines used at wastewater plant. Three engines are located in powerhouse. ,
- * Old cork removed and new backer rod installed. ,
- * Finished application, Belzona® 2221 ready to handle vibration. ,
