# BELZONA PROTECTS PAPER MACHINE STRUCTURAL STEEL

ID: 181

Customer Location: *Pulp and Paper Company in West Virginia, U.S.A.*

Application: *TCC-Tanks and Chemical Containment Areas*

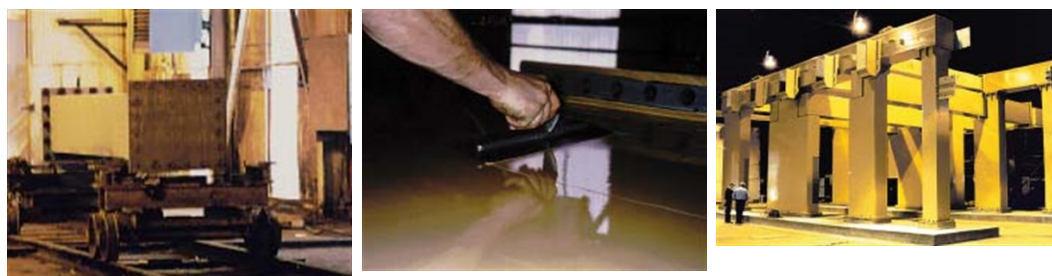
## Photograph Descriptions

\* Following surface preparation by grit blasting, columns and beams were moved by rail to an environmentally-controlled application area. ,

\* Belzona® 5811 brushed and eventually troweled to a smooth finish. ,

\* All beams, columns and plates coated with Belzona® 5811. They were then pre-assembled at the fabrication warehouse to check tolerances. ,
