# BELZONA SLIDES THE CHIPS OFF THE BARK SHAKER

ID: 182

Application: *SHM-Solids Handling Machinery*

Customer Location: *Pulp Mill in Alabama, U.S.A.*

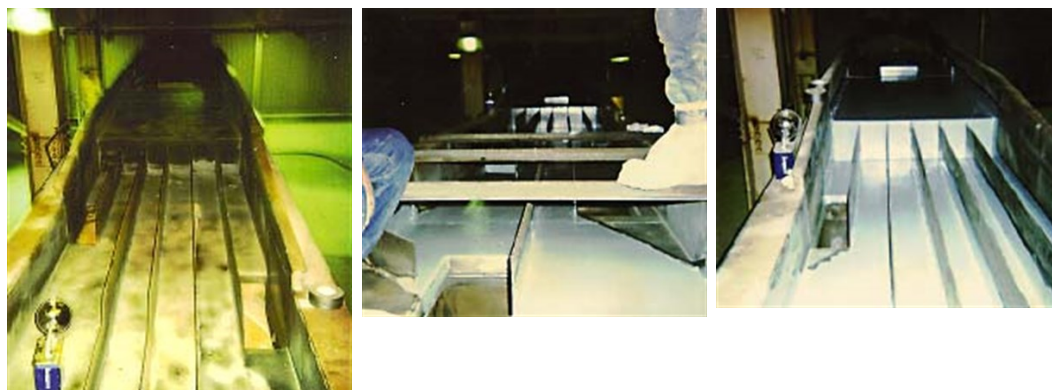
*Bark builds up and clogs the shaker.*

\* The bark shaker. ,

\* Belzona® 1341 provides a slick surface and the bark slides off. ,

\* Another view of the 30 foot long, 8-foot-wide bark shaker coated with two coats of Belzona® 1341. ,

The application was carried out in accordance with Belzona Know-How Leaflet SHM-13.

The application is touched-up every two years and prevents the bark from sticking to the steel. Recently, a new bark shaker has been coated. The customer is extremely happy with the application.
