BELZONA® 5111 HAS EXCELLENT U.V. RESISTANCE

ID: 183

Industry: *Pulp & Paper*
Application: *TCC-Tanks and Chemical Containment Areas*
Substrate: *Concrete steel and galvanized metal*
Products: ** Belzona® 5111 (Ceramic Cladding),*

Customer Location: *Paper Mill in Texas - Wastewater section*
Application Date: *1989*

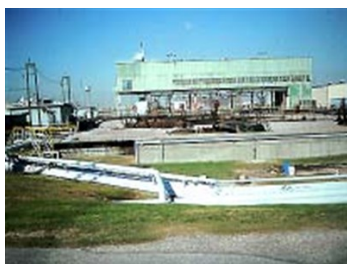
Photograph Descriptions

The structures were damaged from exposure to fumes and vapors inherent to the plant.

- * Building outer walls coated with Belzona® 5111 (Ceramic Cladding). ,
- * Pipework coated with Belzona® 5111 (Ceramic Cladding). ,
- * Even the roof was coated. ,

10,000 sq. feet of small concrete block buildings, pipework and roof.

The application was carried out in accordance with a modified version of Belzona Know-How Leaflets TCC-5, HEX-12 and RPA-1.

After eight years of service, the Belzona® 5111 system continues to provide an aesthetically pleasing coating for the customer.
