# BELZONA PROTECTS EVAPORATOR TUBE SHEETS

Customer Location: *Pulp and paper mill in British Columbia, Canada.*

Application: *HEX-Heat Exchangers*

Evaporator tube sheet.

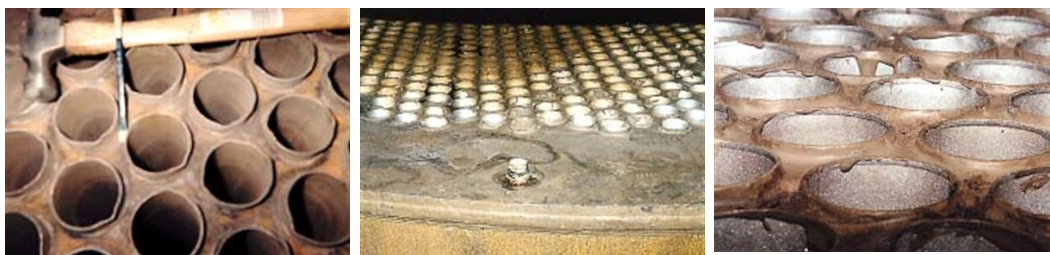
*Erosion/corrosion of the tube sheet due to hot caustic (black liquor at 185°F) and galvanic corrosion due to dissimilar metals.*

- \* Inspection of previous coating shows degradation. ,
- \* One year of Belzona® 1391 coating exhibits no signs of degradation. ,
- \* Close-up view. Substrate is protected with Belzona® 1391. ,

The application was carried out in accordance with a modified version of Belzona Know-How Leaflet HEX-1.

Belzona has been protecting evaporator tube sheets at this mill for several years. Erosion/corrosion is retarded. The life cycle of the equipment is extended and overall maintenance costs reduced.
