# BELZONA SKYLIGHT WEATHERPROOFING

**Customer Location:** Luxury Resort on the Atlantic Coast in Northern Florida, U.S.A.

**Application:** RPA-Roof Problem Areas

Rainwater leakage through skylight

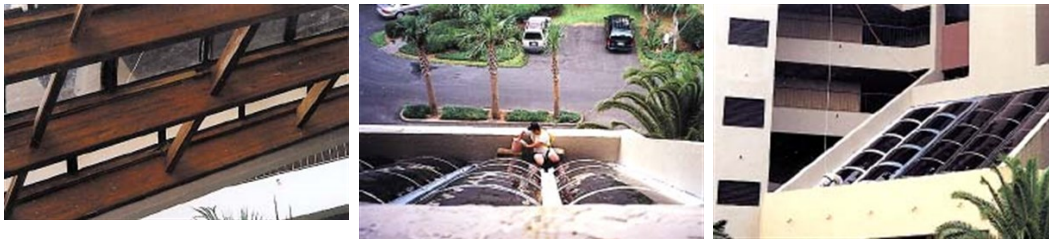
- \* Water leakage was causing problems to the timbers supporting the structure. ,
- \* Application in progress. ,
- \* The entire 30 x 45 feet of skylight was weatherproofed. ,

Application was carried out in accordance with Belzona Know-How Leaflets RPA-3 and RPA-6.

The resort was considering replacement of the entire skylight at a cost of \$65,000. The Belzona solution was accomplished for only 8% of the replacement cost.
