BELZONA SKYLIGHT WEATHERPROOFING

ID: 187

Application: *RPA-Roof Problem Areas*

Rainwater leakage through skylight

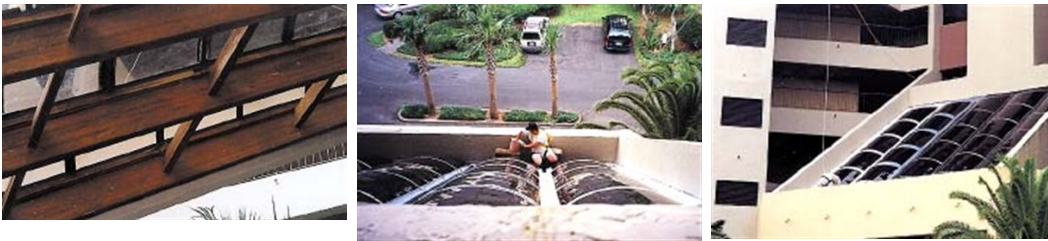
- * Water leakage was causing problems to the timbers supporting the structure. ,
- * Application in progress. ,
- * The entire 30 x 45 feet of skylight was weatherproofed. ,

Application was carried out in accordance with Belzona Know-How Leaflets RPA-3 and RPA-6.
