BELZONA SPECIFIED BY MAJOR CENTRIFUGE MANUFACTURER

Application: *CEP-Centrifugal Pumps*

GHK 1250 horizontal screw centrifuge

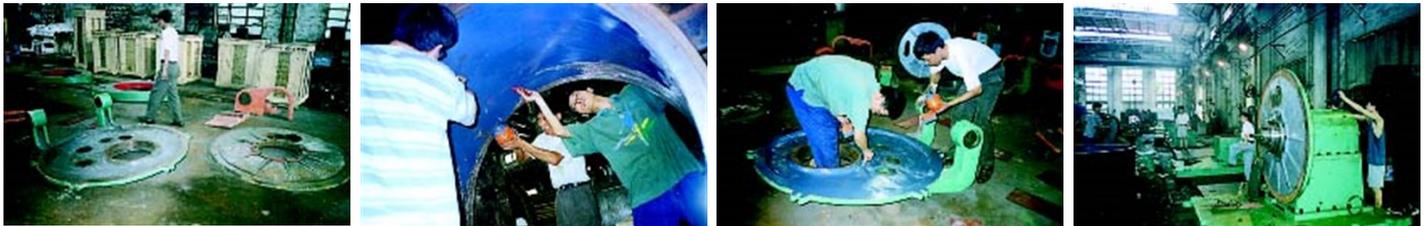
Photograph Descriptions

Corrosion from corn, sulfuric acid (<20%), HCL and lactic acid to contact areas including back plates, casing and inspection hole covers.

- * Surface preparation underway ,
- * Belzona applied to casing ,
- * Belzona applied to inspection hole covers ,
- * Completed application ,

Application was carried out in accordance with a modified version of Belzona Know-How Leaflets CEP-3 and CEP-10.
