# BELZONA PROVIDES POSITIVE GRIP SYSTEM ON DRIVE ROLLERS

Industry: *Chemical & Petrochemical*  
Application: *SHM-Solids Handling Machinery*

Customer Location: *Chemical manufacturer in Louisiana*  
Application Date: *August 1995*

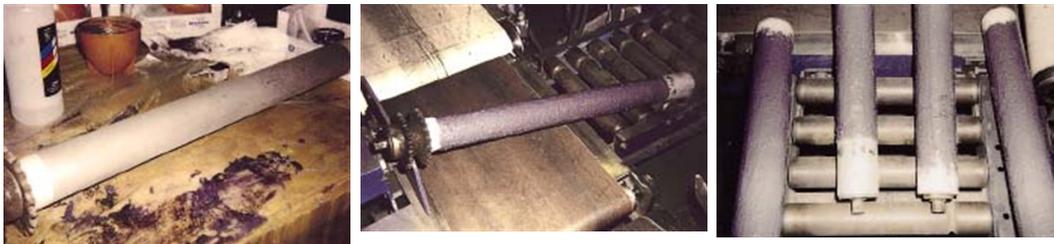
*Non-skid tape was used on the drive rollers, but the weight of the containers peeled off the tape. Every 4 or 5 days the assembly line had to be stopped to repair the rollers.*

- \* A blasted roller ready for application of Belzona® 1321. ,
- \* A single completed roller with sprocket. ,
- \* A series of rollers were done. ,

Drive roller for conveyor system that propels 30-gallon drums and 5-gallon plastic buckets.

The application was carried out in accordance with Belzona Know-How Leaflet SHM-12.

The Belzona Solution allows the conveyor system to run on a more continuous basis and has eliminated weeks of unscheduled downtime. The facility has realized increased production and sustained savings.
