BELZONA PROVIDES POSITIVE GRIP SYSTEM ON DRIVE ROLLERS

Industry: Chemical & Petrochemical
Application: SHM-Solids Handling Machinery

Customer Location: Chemical manufacturer in Louisiana
Application Date: August 1995

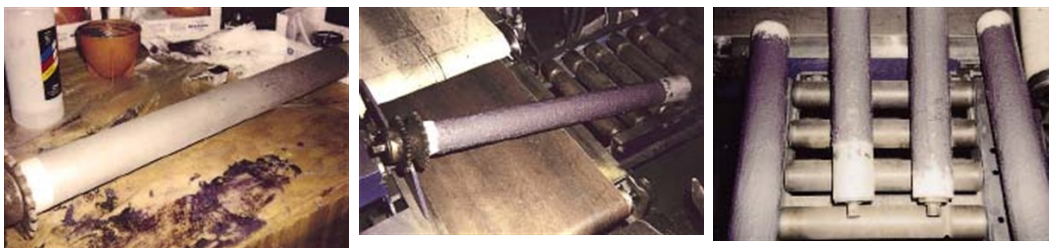
Non-skid tape was used on the drive rollers, but the weight of the containers peeled off the tape. Every 4 or 5 days the assembly line had to be stopped to repair the rollers.

- * A blasted roller ready for application of Belzona® 1321. ,
- * A single completed roller with sprocket. ,
- * A series of rollers were done. ,

Drive roller for conveyor system that propels 30-gallon drums and 5-gallon plastic buckets.

The application was carried out in accordance with Belzona Know-How Leaflet SHM-12.
