# BELZONA® 4111 MAINTAINS SAFE FACTORY ENVIRONMENT

Industry: *General Industry*  
Application: *TCC-Tanks and Chemical Containment Areas*  
Substrate: *Concrete*  
Products: *\* Belzona® 4111 (Magma-Quartz),*

Customer Location: *Manufacturing plant*  
Application Date: *1978 & 1998*

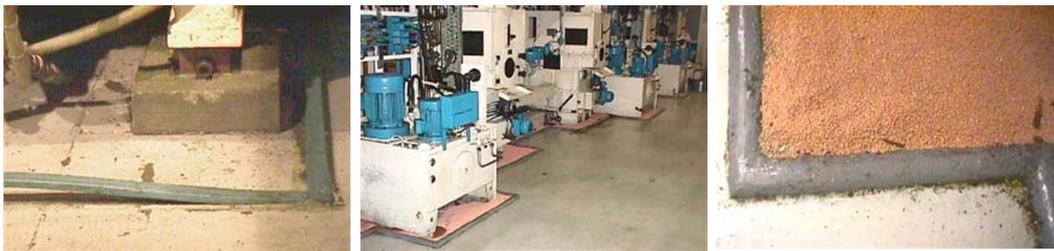
*Leakage of cutting oils, lubricants and printing inks from the machinery create a serious slip and skid hazard.*

- \* Former being positioned ,
- \* General view of machines with formed bunds ,
- \* Close-up of the formed bund ,

Three inch plastic half pipes were used to form the Belzona® 4111 thereby creating a bund or containment area around each machine. The Belzona application has withstood heavy duty use and is resistant to the various oils and chemicals in use. The application also has helped to satisfy hygiene inspectors previously concerned with floor contamination.
