BELZONA RESTORES CRITICAL TOLERANCES IN LIQUID RING VACUUM PUMP

ID: 2154

Industry: *Pulp & Paper*
 Application: *FBC-Fans, Blowers and Compressors*

Customer Location: *Paper mill, Australia*
 Application Date: *December 2005*

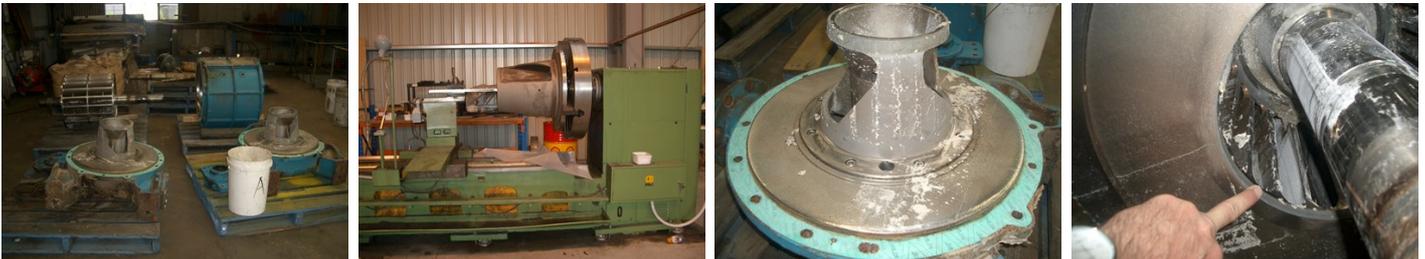
Photograph Descriptions

The pump is subjected to corrosion and “carry over” of the paper pulp. The tolerance between the outside diameter of the cone and the internal taper of the rotor was no longer correct, due to the wear on the cone flange, clearly visible near the bolt holes.

- * A dismantled vacuum pump from Paper Mill ,
- * Cone from 14,000 CFM vacuum pump undercut prior to the application ,
- * The stainless steel cone repaired with Belzona® 1111 after 4 years in service ,
- * The stainless steel rotor is showing significant wear, whereas the Belzona® 1111 applied to the adjacent cone is not ,

The pump cone was inspected after 4 years in service. Despite the aggressive conditions, the Belzona® 1111 is showing virtually no wear. The stainless steel rotor is showing significant wear whereas the Belzona® 1111 applied to the adjacent part (the cone) is not.

Stainless steel cone from a 14,000 CFM vacuum pump. The tolerance between the outside diameter of the cone and the taper of the rotor is critical and must be maintained to allow the pump to operate efficiently.

Application was carried out in accordance with Belzona Know-How System Leaflet FBC-10. The stainless steel cone in this pump was rebuilt with Belzona® 1111 and machined to correct dimensions and taper angle.
