BELZONA PROTECTS GENERATOR ROOM FLOOR

ID: 2157

Customer Location: Telecommunications company
Application Date: February 2007

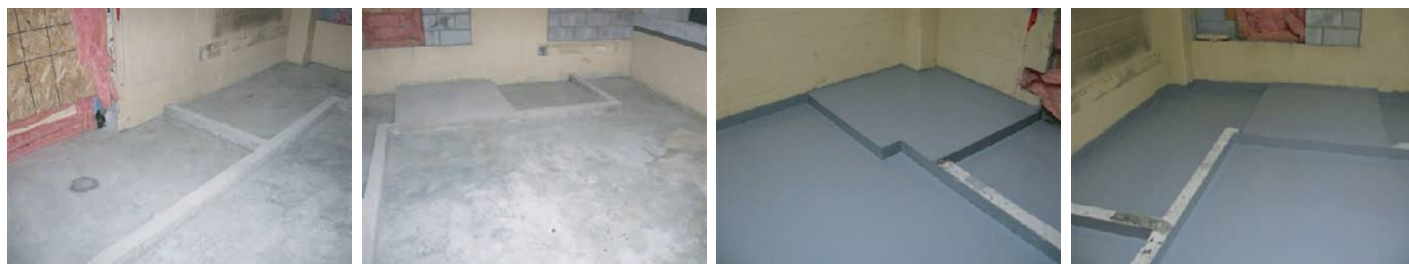
The floor needed to be sealed and protected against fluid spills

- * View of the floor ,
- * View of the floor after surface preparation ,
- * & 4. View of the floor with Belzona® 5811 applied ,

Application carried out according to Belzona Know-How System Leaflet TCC-15.

The Belzona® 5811 coating provides excellent resistance to a broad range of chemicals including the oils liable to be spilt from the generator. The solvent free Belzona® 5811 was ideally suited to application in the confines of the room without interfering with other building occupants in close proximity.
