BELZONA HOT GROUNDWATER PROTECTION

Customer Location: Geothermal Power Plant in Southern California, U.S.A.

Application: HEX-Heat Exchangers

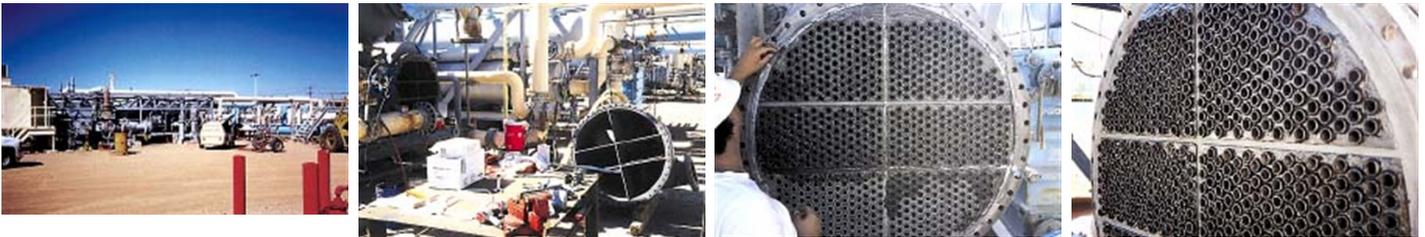
Photograph Descriptions

Hot groundwater contains high levels of minerals, sulfur and abrasives. There is erosion/corrosion of the tube sheet face at elevated temperature.

- * General view of the generating units. ,
- * Tubesheet of vaporizer with head removed. Work station in foreground. ,
- * Application in progress. ,
- * Finished application. ,

The application was carried out in accordance with Belzona Know-How Leaflet HEX-1. Duct tape was used around the circumference and to mask off the division bar areas. Because each tube protrudes, artist brushes were used to coat between the tubes.
