BELZONA SUPPORTS ROBOT WELDING TABLE

ID: 2260

Customer Location: Engineering Co, South West Norway
Application Date: October 2010

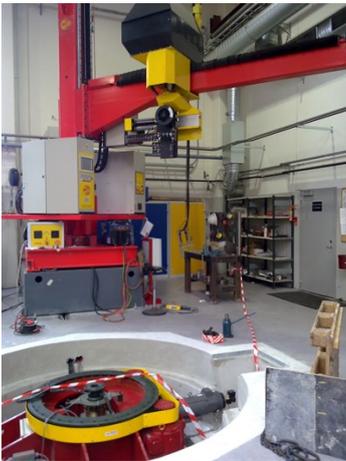
- * Welding table machinery overview ,
- * Void between concrete and steel plate ,
- * Void sealed ,
- * Injection Completed ,

Rotating welding table at workshop fabricating larg parts for the Oil and Gas industry.

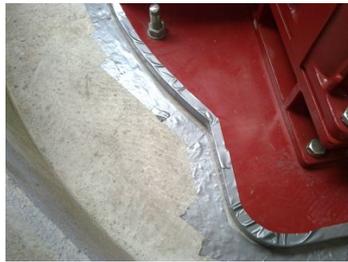
The rotating table is handling parts up to 30 tons in weight. The customer needed to fill the void between the concrete and the steel foundation plate to ensure accurate leveling and transfer of forces.

Application was carried out in accordance with Belzona System Leaflet GSS-9. The void between the concrete and steel plate was sealed off using Belzona® 1161. Belzona® 5811 was then injected through specially prepared injection points allowing the void to be completely filled.
