# BELZONA REFURBISHES STEPS AT HISTORIC COLLEGE

**Industry:** Buildings & Structures  
**Application:** FPA-Floor Problem Areas  
**Substrate:** Stone  
**Products:** \* Belzona® 4131 (Magma Screed) ,

**Customer Location:** College, Oxford, UK  
**Application Date:** September 2011

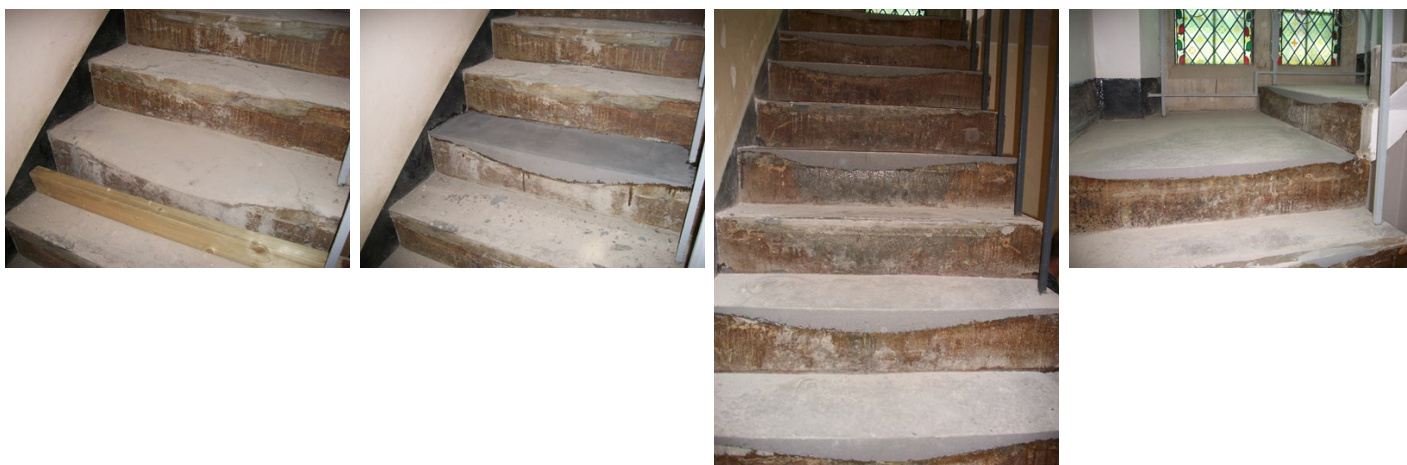
The steps had worn badly over the last few hundred years. The main contractor had to find a product that they could apply in the evening shift so the staircases could be re-opened ready for the busy work force in the morning to carry on with the rest of the project. The contractor only had six weeks to complete the total College refurbishment.

- \* Worn steps before the application ,
- \* Steps during the preparation ,
- \* Steps rebuilt back to profile ,
- \* Completed application ready for the overlay of carpet ,

The College was undergoing a complete refurbishment of the student accommodation area. Part of the work was to rebuild the two staircases at both ends of the building.

Application was carried out in accordance with Belzona Know-How System Leaflet FPA-1.

The contractor chose Belzona as he had previous experience with the products and knew he could have the stairs repaired and back in service in the short time available. The excellent wear characteristics will also ensure steps do not require repair in the foreseeable future.
