# BELZONA PREVENTS GALVANIC AND CREVICE CORROSION ON A RUDDER HORN

ID: 23

Industry: *Marine*  
Application: *SOS-Ships and Offshore Structures*

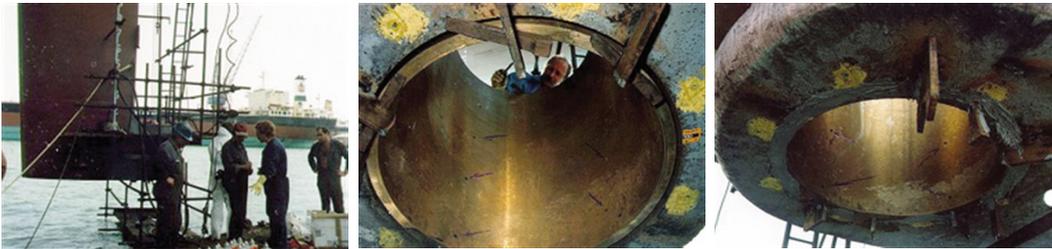
*Corrosion of internal of Rudder Horn had allowed the press fitted bronze bearing to become free. Bearing was approximately 908mm (36-inch) diameter and 1050mm (41-inch) long.*

- \* Belzona materials and team prepared for application. ,
- \* Internal shot of bearing. Note arrows for injection ports. ,
- \* Bearing after injection and prior to cleaning up of the Belzona® 1211 seal. ,

Corrosion to internal of rudder horn of 280,000 Ton VLCC (Very Large Crude Carrier) required re-fixing of bearing.

The bearing was aligned and its position in the housing fixed using alignment bolts. The top and bottom of the housing were sealed using Belzona® 1211, then Belzona® 1321 was injected from below into the space behind.

This method is used both in new-build and repair, and this example illustrates the ability to undertake this work while the vessel is afloat. Use of the Belzona materials isolates and permanently fixes the bearing into position preventing galvanic and crevice corrosion.
