# BELZONA IMPROVES EFFICIENCY AT MILL

ID: 230

Application: *SHM-Solids Handling Machinery*

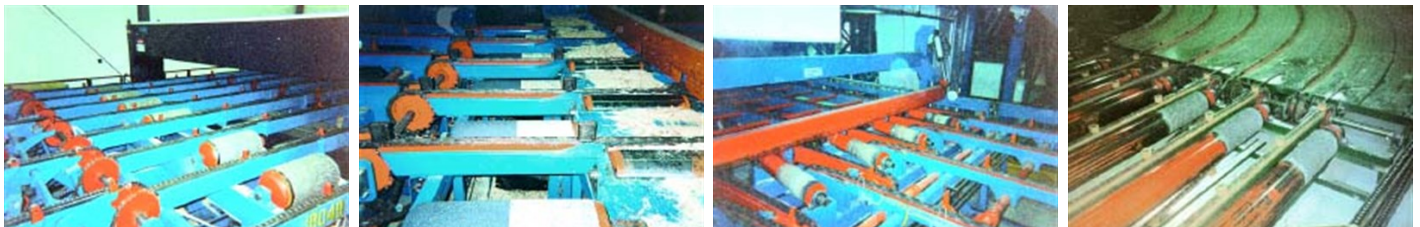
- \* Optimizer scanner in-feed ending rolls coated ,
- \* Canter out-feed ending rolls coated ,
- \* Canter feed rolls coated ,
- \* Sorter table ending rolls - Belzona used as a braking surface ,

*Lumber is transferred from one section to the next by a system of transfer rolls. To prevent slippage, past practice was to weld knobs or streaks across the roll surface. This would simply bounce the lumber to where it was required.*

Application was carried out in accordance with a modified version of Belzona Know-How System Leaflet SHM-12.
