BELZONA PROTECTS NEWLY CONSTRUCTED BUND

ID: 2367

Industry: Chemical & Petrochemical
Application: TCC-Tanks and Chemical Containment Areas

Customer Location: Petrochemical plant, Canada
Application Date: October, 2007

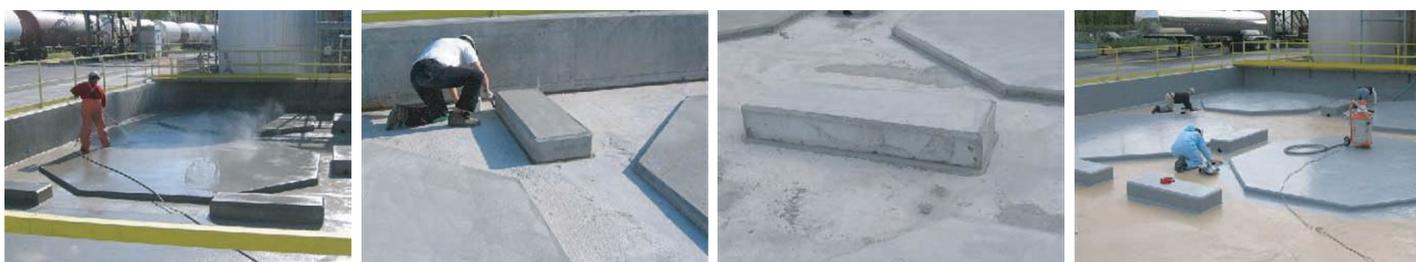
Photograph Descriptions

- * Surface preparation underway ,
- * Application of the Conditioner ,
- * Belzona® 4111 fillet applied to floor/wall joints ,
- * Application of Belzona® 5811. Note use of two colours to assist application ,

The application was carried out in accordance with Belzona Know-How System Leaflet TCC-15. Wall/floor interfaces were reinforced with a fillet of Belzona® 4111 before coating overall with Belzona® 5811.
