BELZONA PROVIDES NON-SKID PROTECTION FOR A SWEET PROBLEM

Industry: Sugar
Application: FPA-Floor Problem Areas
Substrate: Concrete
Products: * Belzona® 4411 (Granogrip-yellow) ,
* Belzona® 9211 (Super Grip) ,

Customer Location: Sugar beet mill - California, U.S.A.
Application Date: February 2000

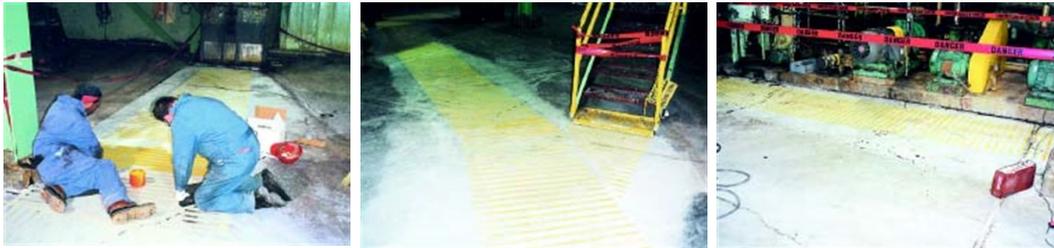
Photograph Descriptions

Sugar juice and by-products on floor cause an extreme slip hazard.

- * Masking tape has been laid down to create stripe pattern ,
- * Pedestrian areas can be made slip-resistant ,
- * Process areas are also protected ,

Application of non-skid system to pedestrian access areas.

The application was carried out in accordance with a modified version of Belzona Know-How System Leaflets FPA-8.

Wet access areas create a serious safety risk. The Belzona non-skid system provides a durable, chemically resistant coating system with superior adhesion to the concrete surface.
