# BELZONA GIVES NEW LIFE TO POWER PLANT ROOF

Industry: Power  
Application: RPA-Roof Problem Areas  
Substrate: Concrete  
Products: \* Belzona® 3111 (Flexible Membrane),

Customer Location: Nuclear Power Plant, Maryland  
Application Date: 1999-2000

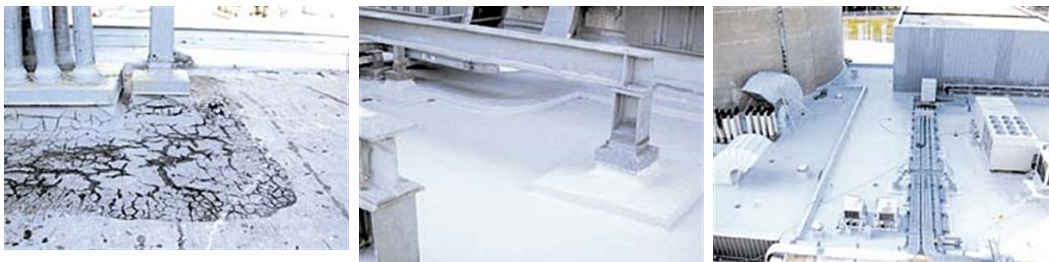
## Photograph Descriptions

*The traditional built-up roof and conventional roof system with insulation had failed with numerous leaks. Previous attempts to repair the roof had failed so the power plant turned to Belzona for a long-term solution.*

- \* Existing condition ,
- \* Completed area ,
- \* Another view of the roof area completed ,

Deteriorated built-up roof, leaks, numerous roof penetrations for HVAC etc.

The application was carried out in accordance with Belzona Know-How System Leaflet RPA-1.

Conventional roofs were explored but Belzona Flexible Membrane was the only product to provide a completely seamless surface to the degree the power plant desired. The savings achieved will allow the plant to complete two additional roofs that were previously unable to be funded.
