FOUR LARGE CONDENSERS PROTECTED WITH BELZONA

ID: 2453

Customer Location: Nuclear power plant, Jaslovské
Bohunice, Slovakia

Application: HEX-Heat Exchangers

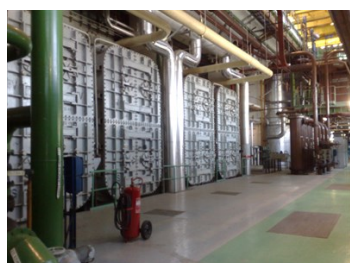
- * 1 condenser 4 boxes on one side ,
- * Before reconstruction ,
- * Test for the surface contamination ,
- * Tubesheet and water boxes protected with Belzona ,

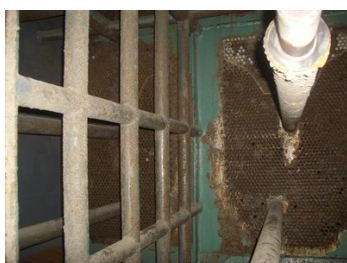
The client wanted to protect new tube sheets against bimetallic corrosion and tubes against corrosion/erosion. Also required to protect the condenser water boxes.
