# FOUR LARGE CONDENSERS PROTECTED WITH BELZONA

Customer Location: Nuclear power plant, Jaslovské Bohunice, Slovakia

Application: HEX-Heat Exchangers

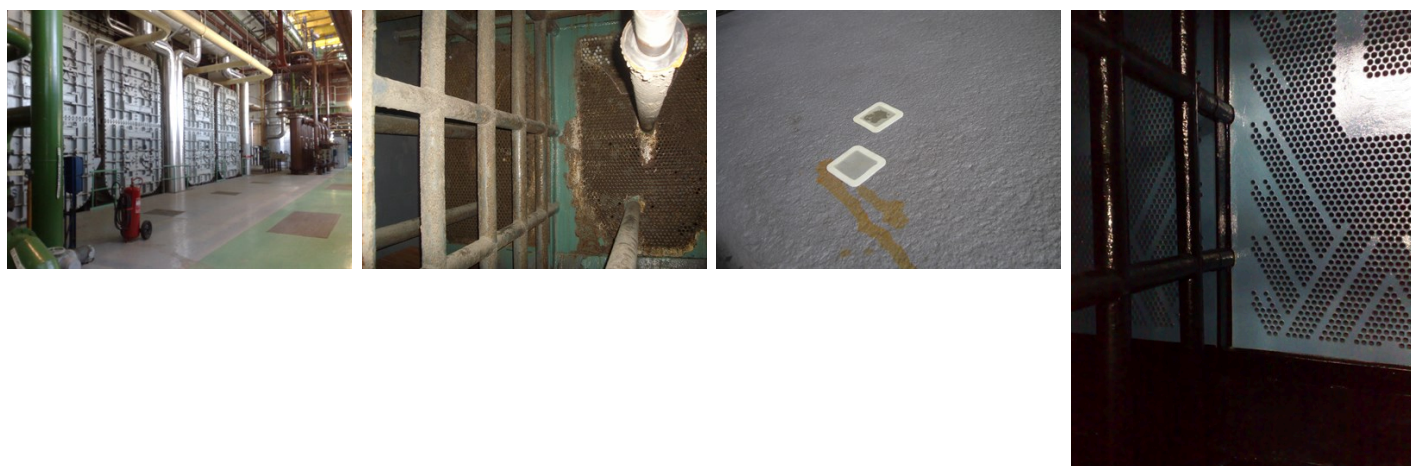
- \* 1 condenser 4 boxes on one side ,
- \* Before reconstruction ,
- \* Test for the surface contamination ,
- \* Tubesheet and water boxes protected with Belzona ,

Each tube (diameter 22 mm) was protected with Belzona® 1341 up to 15 cm inside by special roller. Water boxes were sprayed with Belzona® 5811, whilst tubesheets were protected with Belzona® 1341. The job was done in 2 shifts (12 hours/shift) per day.
