FOUR LARGE CONDENSERS PROTECTED WITH BELZONA

ID: 2453

Customer Location: Nuclear power plant, Jaslovské Bohunice, Slovakia

Application: HEX-Heat Exchangers

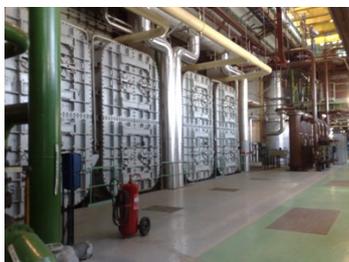
- * 1 condenser 4 boxes on one side ,
- * Before reconstruction ,
- * Test for the surface contamination ,
- * Tubesheet and water boxes protected with Belzona ,
