# BELZONA INCREASES JET DRIVE EFFICIENCY ON THIS HIGH SPEED YACHT

Customer Location: Private, high-speed motor yacht in Florida, USA

Jet Drive Transom Bowl on a large high speed yacht.

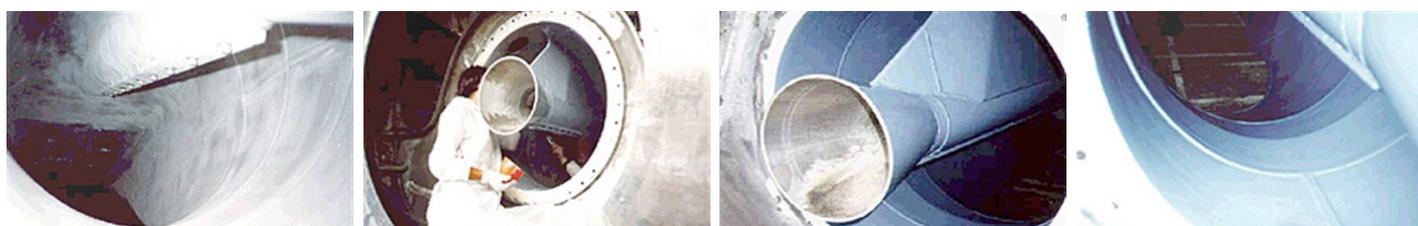
## Photograph Descriptions

Galvanic corrosion and cavitation. Erosion accelerated by entrained solids.

\* Inlet tunnel, prior to surface preparation , \* Application in progress , \* & 4. Ready for service ,

After blasting the substrate to a 3-mil profile, all the irregular surfaces were faired with Belzona® 1111 and then coated with two coats of Belzona® 1341. The application was carried out in accordance with Belzona Know-How System Leaflets SOS-1 and SOC-2.
