# BELZONA® 4311 PROTECTS AGAINST SULFURIC ACID

Application: CEP-Centrifugal Pumps

Customer Location: Petrochemical Plant in Quebec, Canada

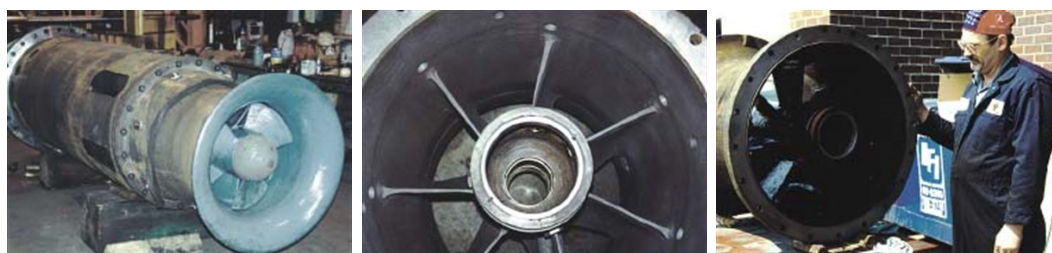
## Photograph Descriptions

Chemical attack

- \* The acid pump ,
- \* Inside view following surface preparation by grit blasting ,
- \* The satisfied contractor admiring his work ,

Vertical pump used for mixing a sulfuric acid solution

Tremendous cost savings resulted due to the fact that the very expensive mixing pump has been preserved. At this facility, five identical acid pumps were treated with two coats of Belzona® 4311 (Magma CR1).
