# BELZONA LOW ODOUR SOLUTION FOR TRAINING COLLEGE ROOF

ID: 2825

**Customer Location:** Police Training College, South East England

**Application:** RPA-Roof Problem Areas

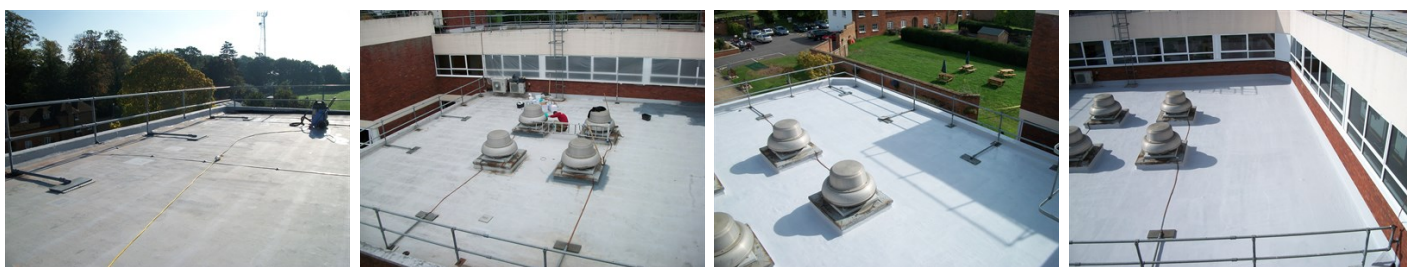
- \* The roof being washed down ready for the repairs and coating ,
- \* Preparation completed and the Conditioner being applied ,
- \* First and second coats of Belzona® 3111 completed ,
- \* Completed application of Belzona® 3111 system ,

Application was carried out in accordance with Belzona Know-How System Leaflet RPA-8. Damage in the asphalt was repaired with Belzona® 4111 before the complete roof was sealed with a fully reinforced Belzona® 3111 System.
