BELZONA IMPROVES PROTECTION AT BASE OF CHIMNEYS

ID: 2946

Application: ENC-Engines and Casings

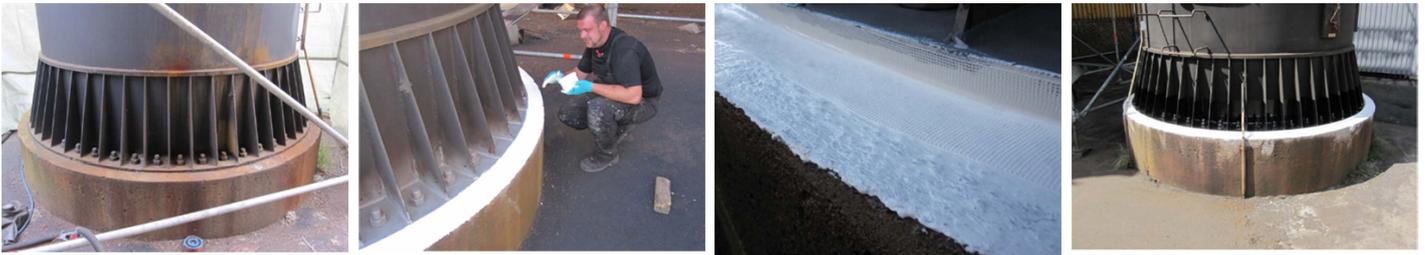
Photograph Descriptions

The chimneys are made of steel and are resting on a concrete base. Moisture between the chimney and the supporting concrete resulted in corrosion taking place on the chimney as well as a high risk for frost heave in the concrete.

- * Chimney Base for the furnace before the repair ,
- * Application of Belzona® 3211 ,
- * Reinforcement sheet incorporated into the Belzona® 3211 coating bridging the steel/concrete junction ,
- * The finished application with Belzona® 5811 providing corrosion protection on the steel chimney ,

Application was carried out in accordance with Belzona Know-How System Leaflets GSS-3 and TCC-5. After grit blasting the repair area, the steel was protected with Belzona® 5811 and the Belzona® 3211 reinforced system was applied across the junction between steel and concrete.
