# BELZONA HELPS TO KEEP WORKSHOP CLEAN AT CIDER PLANT

ID: 2954

Application: WPA-Wall Problem Areas

Customer Location: Cider Producer, Herefordshire, UK

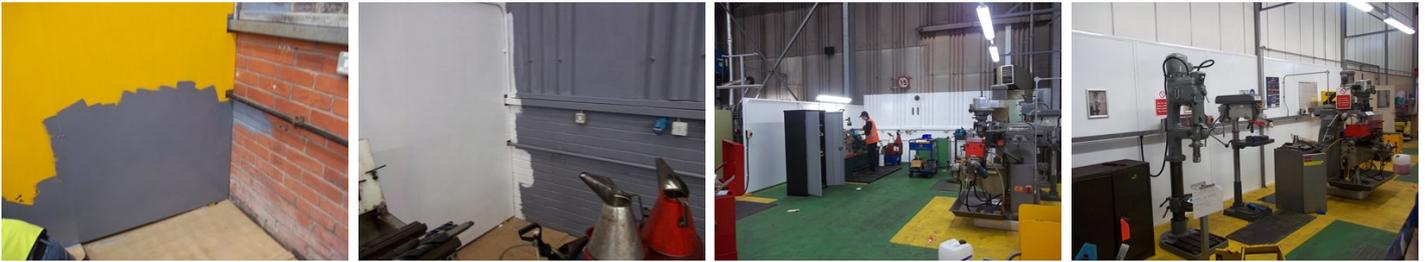
## Photograph Descriptions

- \* Application of Belzona® 5911 Conditioner ,
- \* Application of First Coat of Belzona® 5111 ,
- \* Completed application ,
- \* New brighter, cleaner working area ,

Application was carried out in accordance with Belzona System Leaflet WPA-2

Belzona® 5111 was the only product they could find to fill all of their requirements. Its excellent chemical and abrasion resistance allows for easy cleaning enabling clean bright environment to be maintained.
