MAJOR BELZONA SAFETY REPAIRS IN BOTTLING HALL

ID: 3010

Customer Location: Distillery, Glasgow, UK
Application Date: November 2011

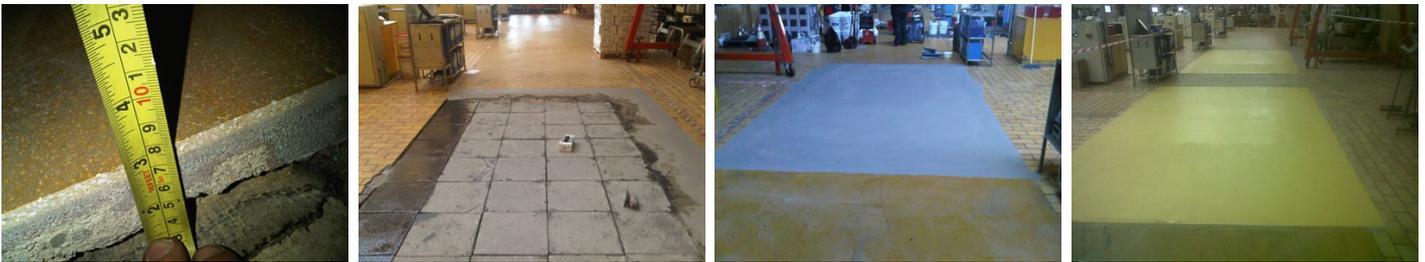
Photograph Descriptions

The areas were approximately 80mm deep and required filling and levelling. The three areas were a severe safety risk to the trucks operating in the plant leading to imbalance and disruption to production. The repairs had to be completed over a weekend shut-down.

- * Depth and problem of repairs required ,
- * Concrete slabs being bedded in prior to final Belzona® 4131 screed ,
- * Finished screed application ,
- * 2 coats of Belzona® 5231 with encapsulated aggregate applied for safety and grip ,

Three areas of extremely uneven flooring in the bottling hall. Areas included failing quarry tiles, epoxy screed and concrete.

Application was carried out in accordance with Belzona Know-How System leaflet FPA-1. After breaking out the failed epoxy flooring, quarry tiles and deteriorated concrete the levels were made up by bonding pre-cast concrete slabs into place before applying a 6mm screed of Belzona® 4131. Finally 2 coats of Belzona 5231, incorporating additional aggregate, were applied to create non-slip surface.
