BELZONA RESOLVES WATER INGRESS ISSUES IN SCHOOL CORRIDOR WALKWAY

ID: 3011

Customer Location: Junior School, Chesterfield UK
Application Date: 2010

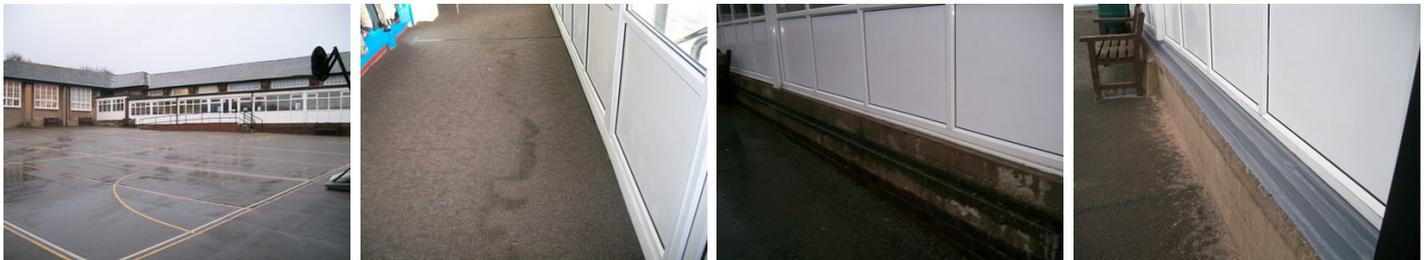
Photograph Descriptions

Approximately 8 years prior to the Belzona application the corridor walkways had been enclosed to provide a safe and warm environment for children and staff to travel around the school. Within a couple of years there was water ingress causing dampness to the carpeting and presenting a potential slip risk. The problem was identified as failing sealant between the UPVC panels and the original brick and cement rendered structures. Over the 6 years several attempts were made to reseal but all had failed.

- * View of the corridor walkway from the playground ,
- * View from within the corridor walkway with water staining to the carpet clearly evident ,
- * Close up view of the main areas of water ingress ,
- * Completed Belzona® 3131 fully reinforced application ,

The application was carried out in accordance with a slightly modified version of Belzona Know-How System Leaflet RPA-1

The repairs were carried out over two days in each of the two sections of corridor walkway. The results were a complete success

allowing the school to replace the water damaged carpet with new, confident that there would be no further water ingress issues via the Belzona® 3131 protected areas.
